Applies To: **See VEHICLES AFFECTED****July 2003**

Product Update: 1998–99 Accord 8-Way Power Driver's Seat

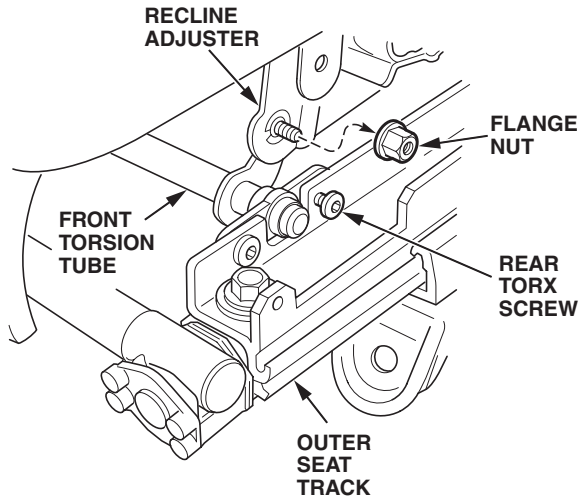
- Loosen the rear Torx screw that attaches the front torsion tube bracket to the outer seat track.
- Look for cracks or other damage on the link welded to the front torsion tube.
 - If the link is OK, go to step 9.
 - If the link is cracked or damaged, replace the seat linkage assembly (refer to the Shop Manual). After you replace the seat linkage assembly, go to step 12.
