Model	Applicable To	File Under	Bulletin No.
1998 ACCORD	See VEHICLES AFFECTED	BODY	98-043
			Issue Date JUNE 1998

Creak From the Rear Shelf Area

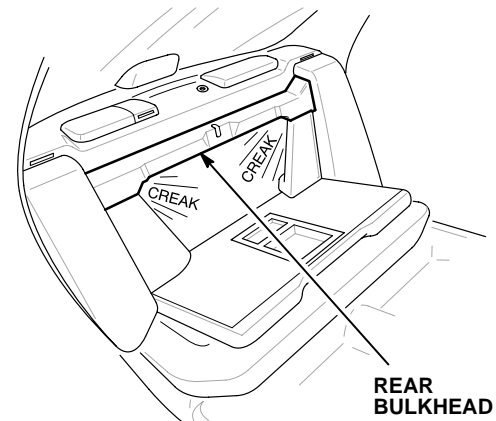
1. Fold down the rear seat-back.
2. Have an assistant in the front passenger's seat listen to the back of the vehicle as you slowly drive over a bump or into a driveway while turning. (Replicating the creak is difficult unless you are driving slowly and turning at the same time.)
 - If either side of the rear bulkhead creaks, go to step 3.

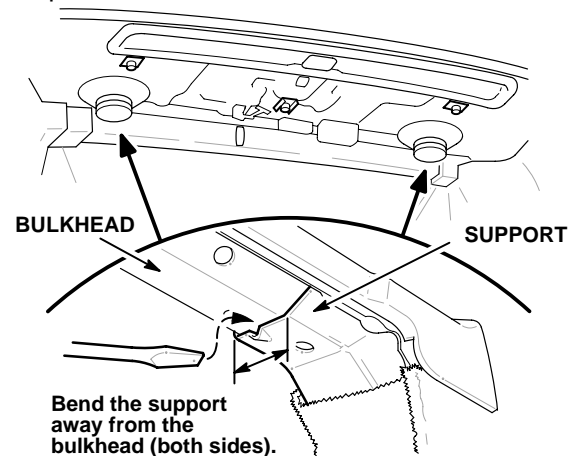
Movement between the rear bulkhead supports and the bulkhead.

3. Carefully bend the lower-outer edge of both rear bulkhead supports away from the bulkhead with a flat-tip screwdriver.
