Model
**1998
ACCORD**

Bulletin No.
98-056

Issue Date
OCTOBER 1998

Inaccurate Fuel Gauge

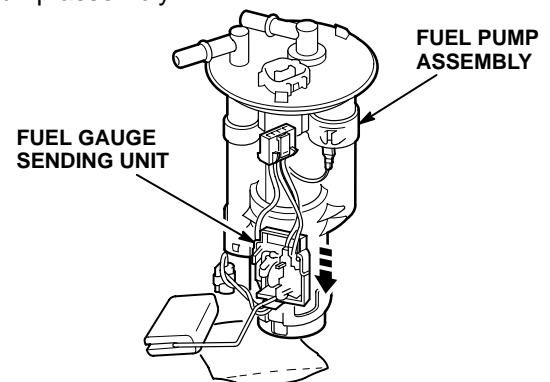
The fuel gauge may not read accurately when it is between 1/2 and Full, and/or the gauge may not go to Full after the tank is filled.

Sulfur in the fuel affects the resistance of the fuel gauge sending unit.

6. Remove the fuel gauge sending unit from the fuel pump assembly.

7. Install the new fuel gauge sending unit on the fuel pump assembly by placing it against the assembly and sliding it up until it locks in place.
8. Reinstall the fuel pump assembly in the fuel tank, and reconnect the electrical connector and lines. Torque the mounting bolts to 4 N·m (3 lb-ft).
9. Reinstall the access cover and the trunk floor.
