## Roof Molding Is Warped or Loose

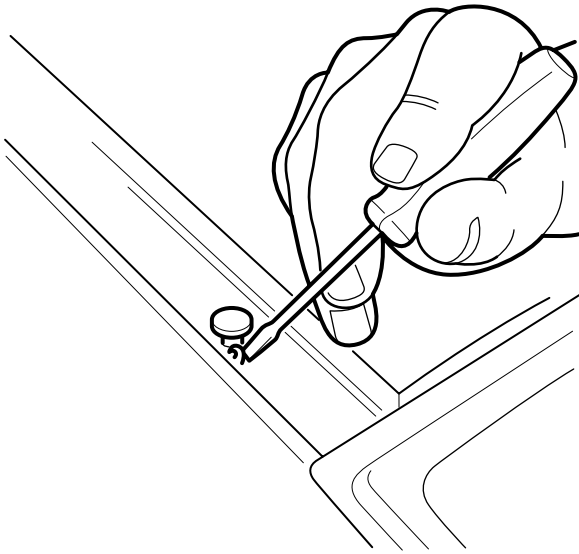
Excess sealer around the base of one or both pins in the roof.

4. Use a flat-tip screwdriver to scrape any excess sealer from around the base of the pins.
