Key Cannot Be Removed From the Ignition Switch

(Supersedes 97-009, dated February 1997)

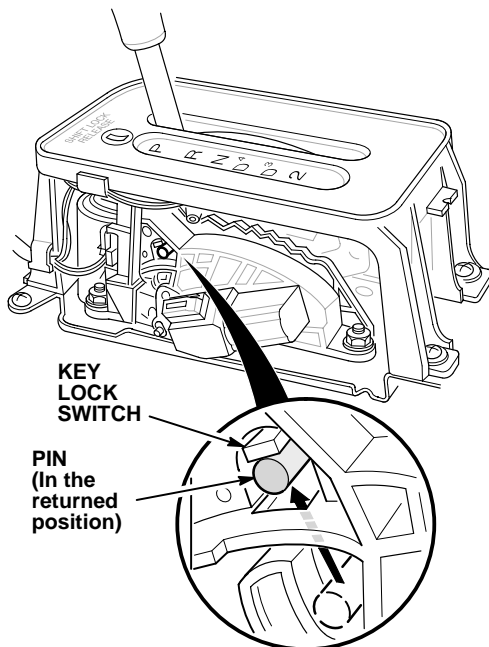
The shift cable is out of adjustment, preventing the pin from engaging in the key lock switch.

1. Make sure the shift lever is in Park.
2. Remove the center console.
3. Inspect the key lock switch. If the pin is not in the switch, move the shift lever back and forth without taking it out of Park.
 - If the pin does not return and the key cannot be removed, continue with normal troubleshooting.
 - If the pin returns and the key can be removed, continue to CORRECTIVE ACTION.

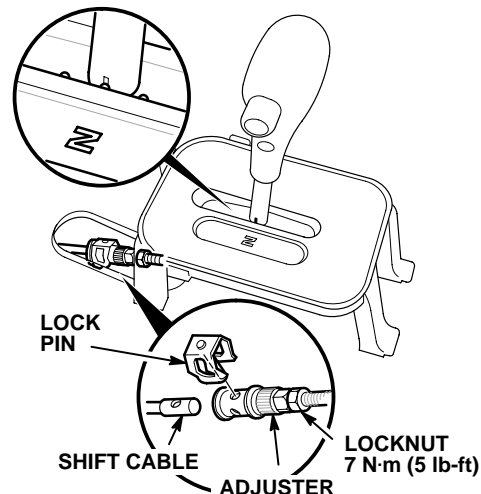
2. Remove the lock pin from the shift cable adjuster.
3. Check the alignment of the hole in the adjuster with the hole in the shift cable. They should align perfectly.

4. Loosen the locknut on the adjuster. Turn the adjuster in or out until the holes align perfectly. Tighten the locknut to 7 N-m (5 lb-ft).
5. Reinstall the lock pin. If the lock pin binds as you install it, the shift cable is still out of adjustment.
6. Move the shift lever to all the gear positions. Verify that the shift lever position indicator shows each position.
7. Move the shift lever to Park. Verify that the key can be removed.
8. Insert the key in the shift lock release slot, and verify that the shift lever releases.
9. Reinstall the center console.
