Model	Applicable To	File Under	Bulletin No.
1996 – 97 CIVIC	ALL	BODY	97-056
			Issue Date NOVEMBER 1997

Sagging Headliner

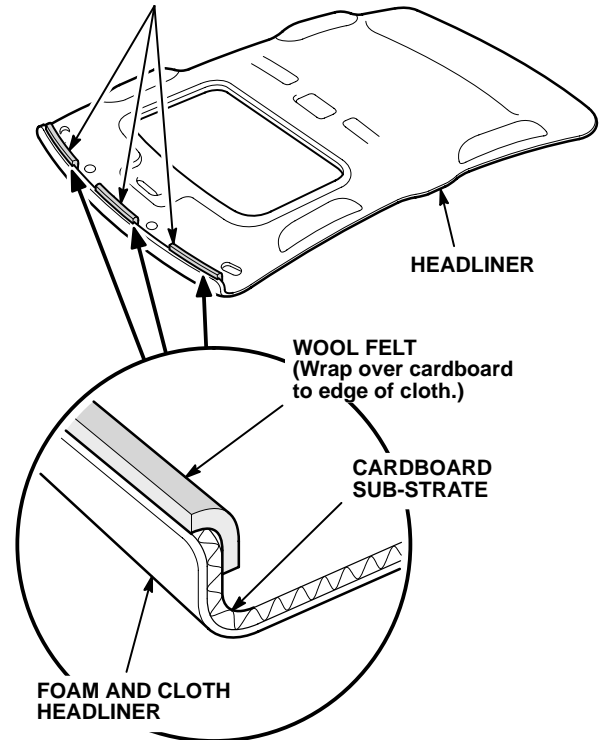
WOOL FELT, 150 mm x 15 mm
(3 places, position as shown.)

4. Apply the strips of wool felt to the front of the headliner as shown.
