| Model | Applicable To | File Under | Bulletin No. |
| 1997 CRV | With ABS Thru VIN JHLRD185. . . VC005467 | BRAKES | 97-033 |

ABS Rear Wheel Speed Sensor Connectors Reversed

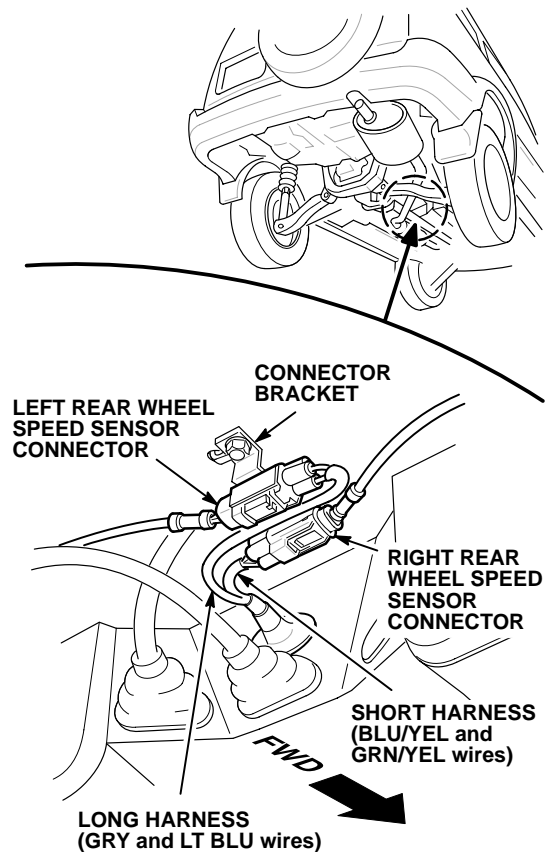
1. Raise the vehicle on a hoist.
2. Locate the orange ABS rear wheel speed sensor connectors in front of the fuel tank.
3. Check that each harness is correctly connected:
 - The short harness (BLU/YEL and GRN/YEL wires) should connect to the *right* rear wheel speed sensor connector and attach to the *front* of the connector bracket.

- The long harness (GRY and LT BLU wires) should connect to the *left* rear wheel speed sensor connector and attach to the *back* of the connector bracket.

4. If the connectors are already correctly connected, perform the procedure in Service Bulletin 97-032, *Under-Hood Emissions Label Correction*. If not, go to step 5.
5. Disconnect both wheel speed sensor connectors from the vehicle wire harness, and remove them from the bracket.
6. Reconnect the connectors as shown in step 3, and reattach them to the bracket. Then perform the procedure in Service Bulletin 97-032, *Under-Hood Emissions Label Correction*.
