1997-99  
CR-V

98-050

## Clunking Noise From the Front Suspension

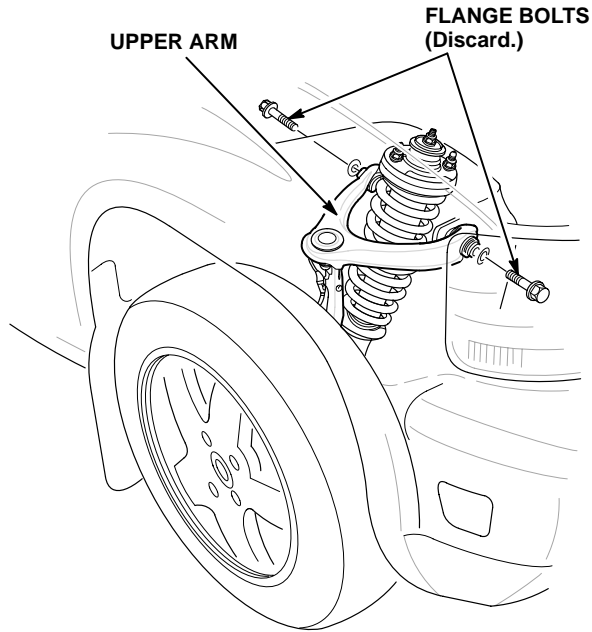
The upper arm flange bolts do not properly clamp the upper arm bushings.

- Loosen the two flange bolts from the right upper arm. Repeat this step on the left side.

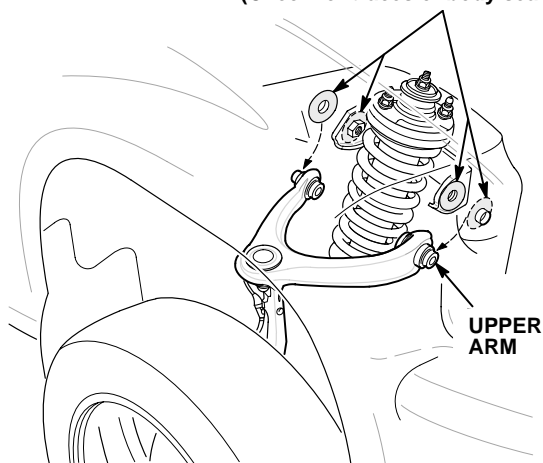
**UPPER ARM MOUNTING AREAS**  
(Check for traces of body sealer.)

- While supporting the right front tire with your hand, remove the flange bolts, and ease the upper arm away from the upper arm mount. Discard the flange bolts. Repeat this step on the left side.
- Raise the vehicle about four feet off the ground.
- From inside the right front wheelwell, look for traces of body sealer in the upper arm mounting areas. If you find any body sealer, remove it with a gasket scraper. Repeat this step on the left side.

NOTE: Be careful not to scratch the body finish. If you do, repair the area with touch-up paint.
