Applies To: **2003 Element 2WD** - From VIN 5J6YH1...3L000001 thru 5J6YH1...3L009372  
**2003 Element 4WD** - From VIN 5J6YH2...3L000001 thru 5J6YH2...3L022688

May 6, 2003

**2003 Element: Windshield Is Cracked at the Lower Corners**

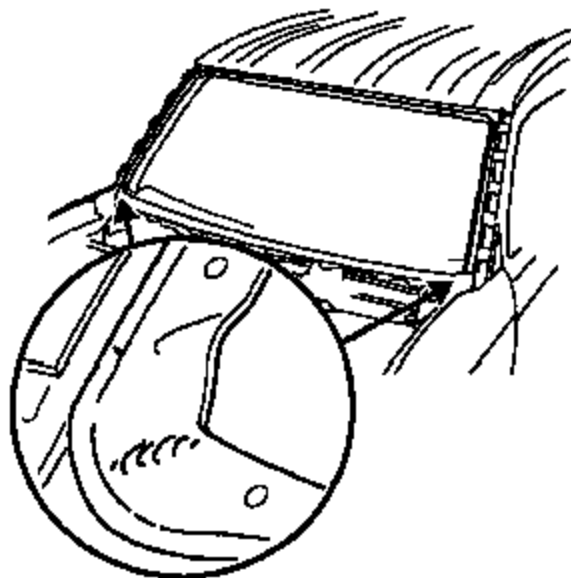
1. Remove the windshield (see page 20-37 in the 2003 Element Service Manual).
2. Inspect the mounting flange for any high spots, especially at the base of the A-pillar where the dashboard attaches.

**NOTE:** You may need to remove some of the sealer to inspect the area.
