Trunk Lid Does Not Close Properly

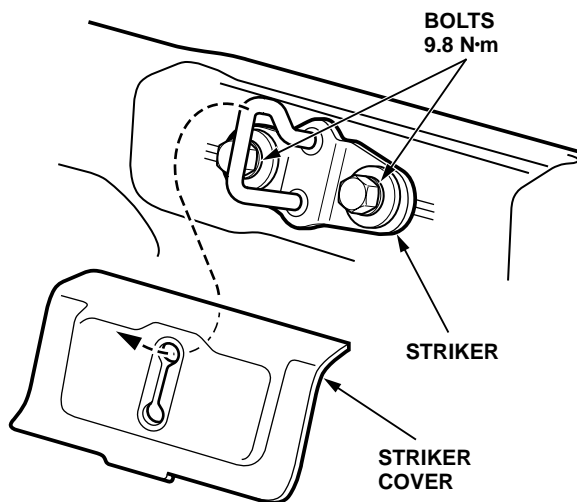
The striker is bent.

1. Remove the rear trim panel (see the Body section of the 1996 Legend Shop Manual).
2. Remove the striker cover.

3. Remove the striker (two bolts).
4. Install the new striker, making sure you place it directly over the original striker position. Torque the bolts to 9.8 N·m.
5. Reinstall the striker cover.
6. Check the operation of the trunk lid, and adjust the striker if needed.
7. Reinstall the rear trim panel.
