Safety Recall: V6 Engine Water Pump

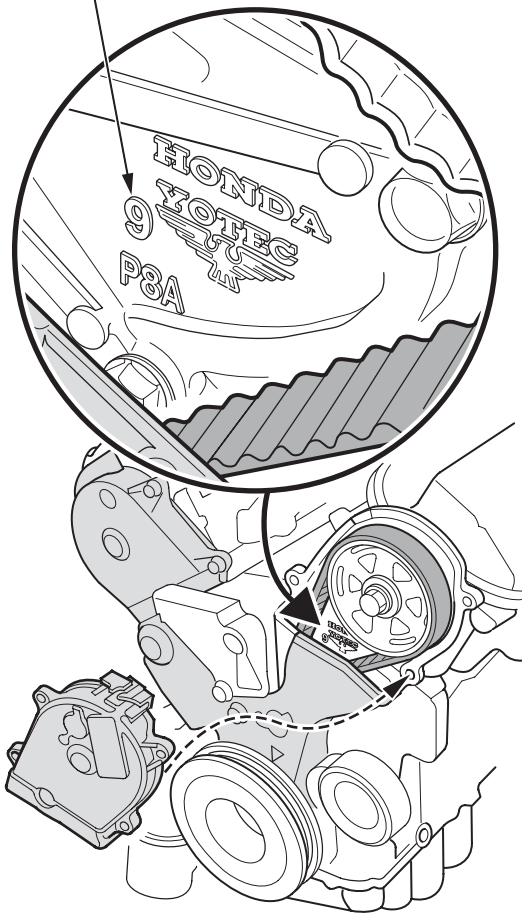
CASTING DIE NUMBER

1. Remove the timing belt front upper cover. Refer to Timing Belt Inspection in the appropriate shop manual.
2. Inspect the casting die number on the water pump housing.
 - If the casting die number is "9," go to **REPAIR PROCEDURE**.
 - If the casting die number is any number other than "9," reinstall all removed parts, and center-punch the VIN.

Inspect the casting die number on the water pump housing. If the casting die number is "9," replace the water pump and the timing belt.
