Model  
**1998  
ODYSSEY**

Bulletin No.  
**98-025**  
Issue Date  
**APRIL 1998**

## Squeak From the Dashboard

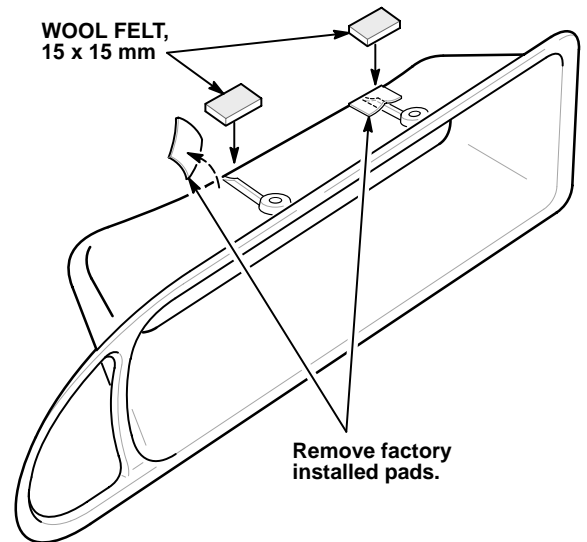
The visor surrounding the instrument panel is rubbing against the lens.

4. Remove the factory-installed pads from the upper ribs.

5. Apply the pieces of wool felt to the upper ribs of the visor.
6. Reinstall the instrument panel visor and side defogger trim.
