| Model | Applicable To | File Under | Bulletin No. |
| 1997 PRELUDE | Thru VIN JHMBB6 ... VC000014 | BODY | 97-048 |

Clunking Noise From the Trunk Area

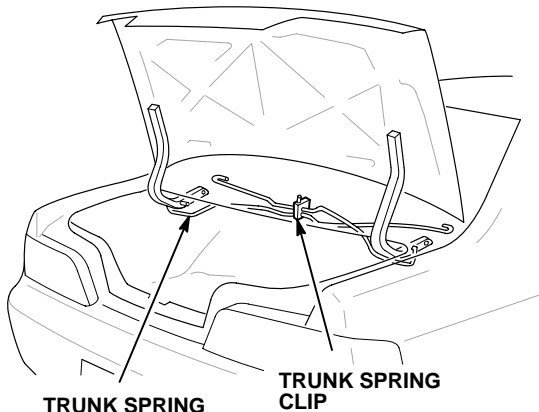
A clunking noise from the trunk area when opening and closing the trunk lid or when driving over bumps.

The trunk spring clip is out of its mounting holes.

Replace the trunk spring clip.

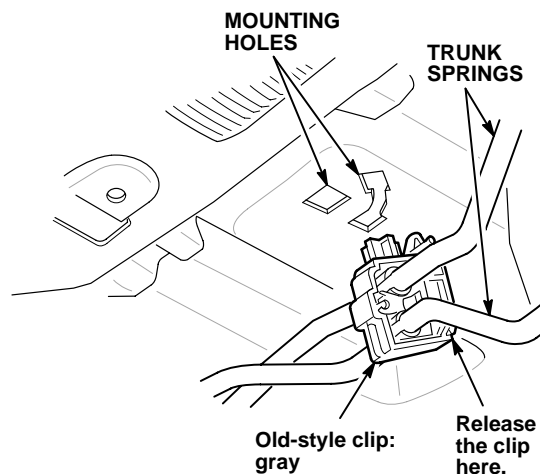
1. Check to see if the trunk spring clip is out of its mounting holes.
