Model
**1998
ACCORD
KK Models
Only**

Bulletin No.
98-039
Issue Date
JUNE 1998

Brake System Indicator Stays On

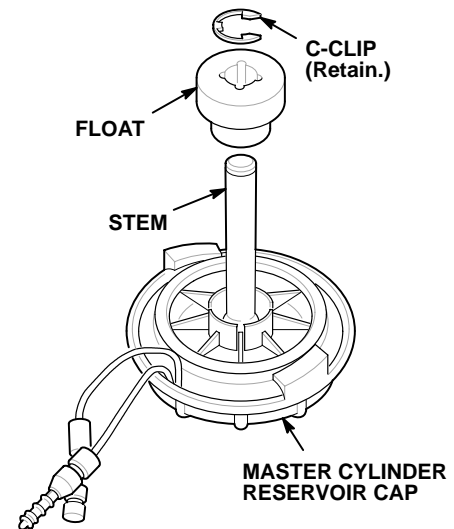
1. Remove the brake master cylinder reservoir cap.
2. Raise the float, and carefully remove the C-clip from the cap stem.

NOTE: The cap stem contains a reed switch that can be easily broken if the stem is flexed.

3. Remove and discard the old float.
4. Install the new float on the stem with the large diameter side toward the C-clip, then carefully install the C-clip.
5. Install the reservoir cap; reconnect the connectors.
6. Verify that the brake indicator functions properly.
