1995-97  
ACCORD

ALL L4 with  
Factory-Installed Air  
Conditioners

98-072

## Recall: Accord Wire Harness Routing

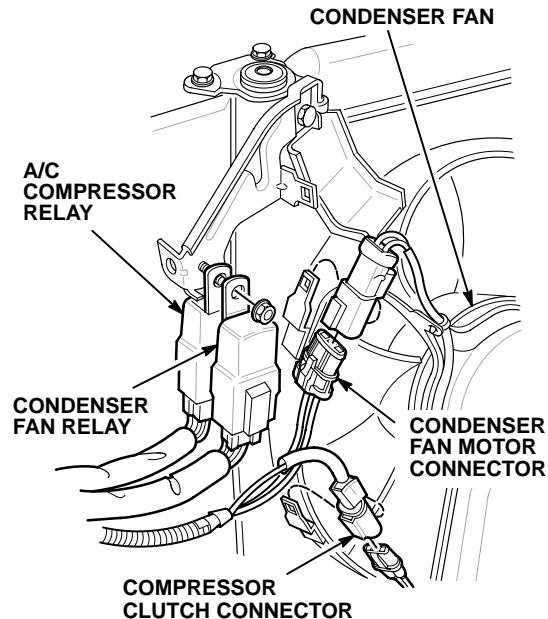
1. Remove the A/C compressor and condenser fan relays mounting nut.

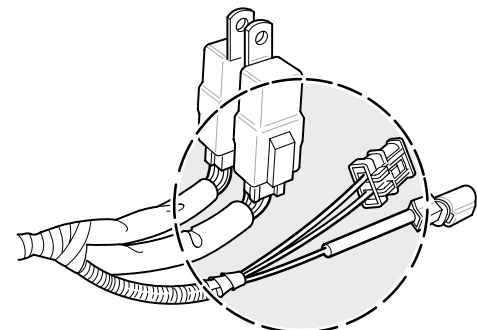
2. Disconnect the condenser fan motor and the compressor clutch connectors.
3. Inspect the wires in the shaded areas as shown for damage to the insulation.
  - If any of the insulation has worn through so that the copper wire strands are showing, then go to REPAIR PROCEDURE A.
  - If there are no copper wire strands showing, even though there may be some damage to the insulation, go to REPAIR PROCEDURE B.

1. Replace the wire harness assembly.
2. Continue to REPAIR PROCEDURE B.

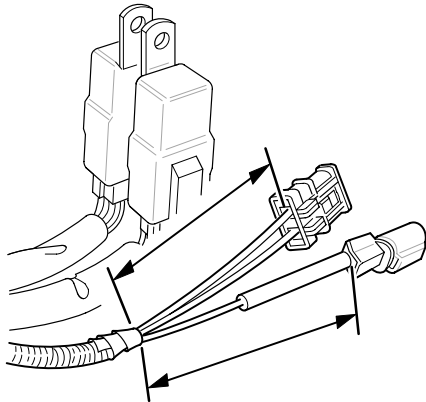
1. Measure the length of wire between the outer sheath and the connectors of the compressor clutch and the condenser fan motor.

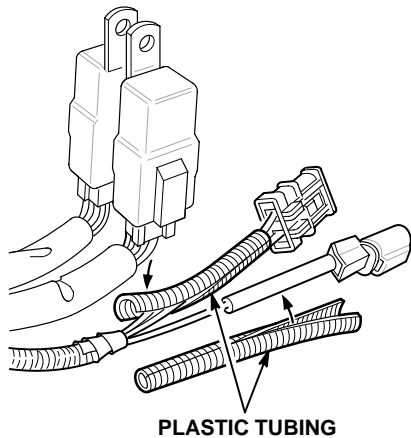
2. Cut two pieces of corrugated plastic tubing (see PARTS INFORMATION) to the lengths measured in step 1.
3. Install the tubing pieces over the wires.

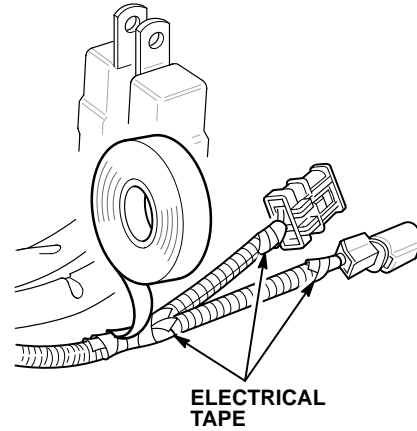
4. Anchor the tubes to the wire harness with 3M electrical tape (see REQUIRED MATERIALS).

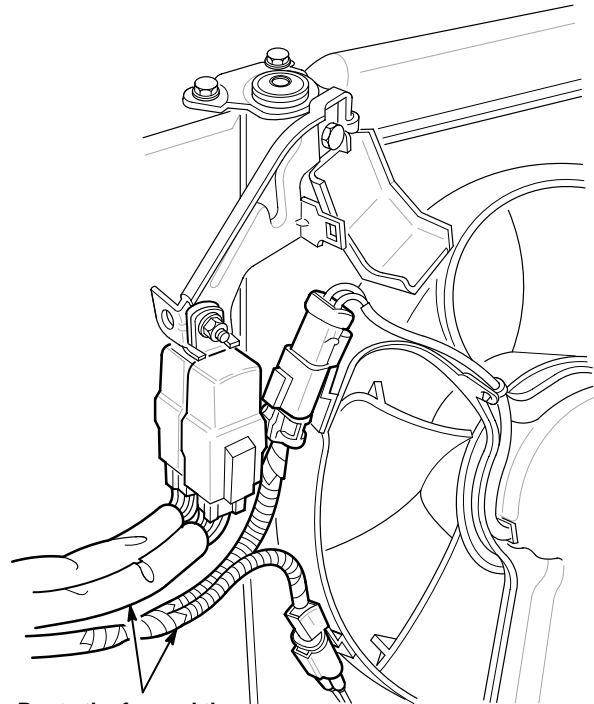
5. Reinstall the relays to the bracket with the original nut.
6. Route the wiring for the compressor clutch and the condenser fan motor, then reconnect the connectors.
