Applies To: **1999 Civic** – ALL
2000 Civic – See VEHICLES AFFECTED

Coolant Leaks From the Reservoir

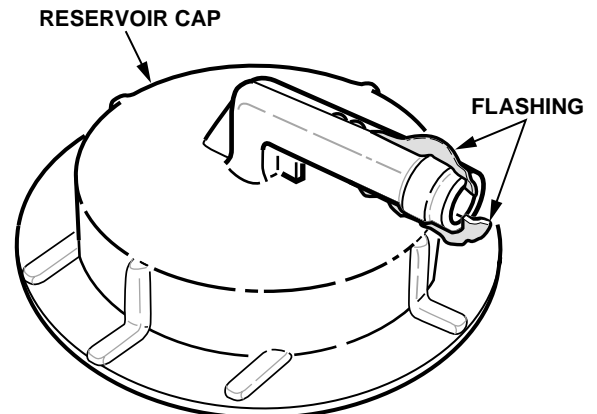
1. Remove the coolant hose from the reservoir cap, and closely inspect the cap outlet for flashing. It may be bent over and difficult to see.
2. With a utility knife, remove the flashing from the outlet.

3. Reinstall the coolant hose. If coolant is still leaking from the hose, replace the reservoir cap.
4. If necessary, add coolant to the radiator and the reservoir, and bleed the cooling system. Refer to the Engine Cooling section of the 1996 Civic Shop Manual.
