Applies To: **2001 Civic** – KK From VIN 1HGEM....1L500001 thru VIN 1HGEM....1L500094
From VIN 1HGES....1L500001 thru VIN 1HGES....1L501737
KX From VIN 1HGEM....1L900001 thru VIN 1HGEM....1L902404
From VIN 1HGES....1L900001 thru VIN 1HGES....1L908929

Creak From the Right Side of the Dashboard

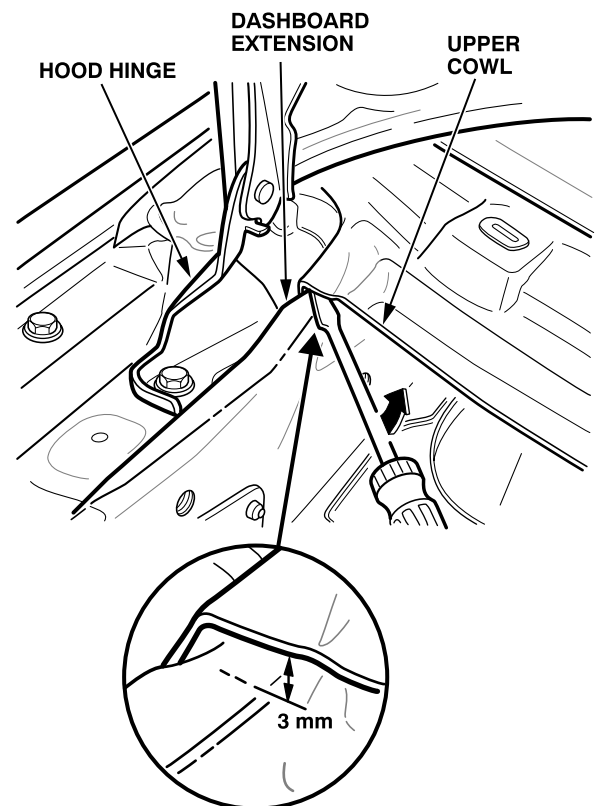
1. Remove the passenger's cowl cover (see the 2001 Civic Shop Manual).
2. Insert a flat-tip screwdriver between the upper cowl and the dashboard extension.

3. Pry the cowl up until it is 3 mm away from the dashboard extension.
4. Reinstall the passenger's cowl cover.
5. Test-drive the vehicle to make sure the noise is gone. If the noise is still there, use a ChassisEAR squeak and rattle finder to pinpoint and repair the source of the noise. To order a ChassisEAR through the Honda Tool and Equipment program, call 262-656-7933.
