Front Bumper Spoiler is Loose or Detached

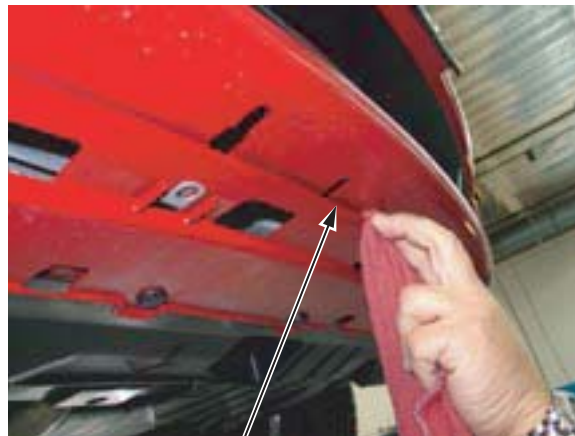
Clean the groove in the front bumper.

1. Remove the front bumper air spoiler.
2. Clean the grooves in the front bumper and the air spoiler with isopropyl alcohol.

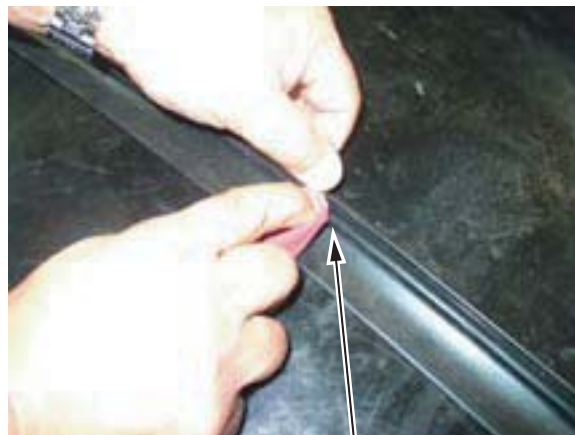
Clean the groove in the air spoiler

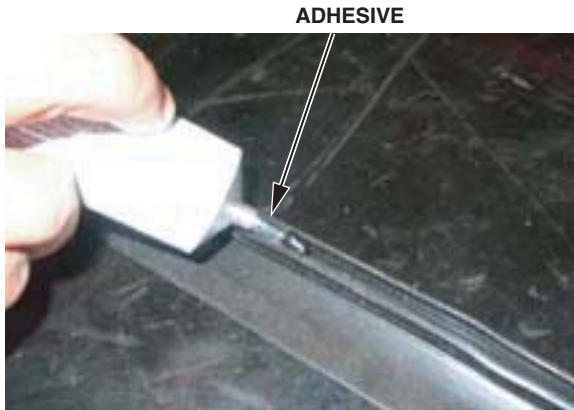
3. Apply a small bead (3 to 5 mm) of 3M Weatherstrip Adhesive in the groove in the front bumper air spoiler.

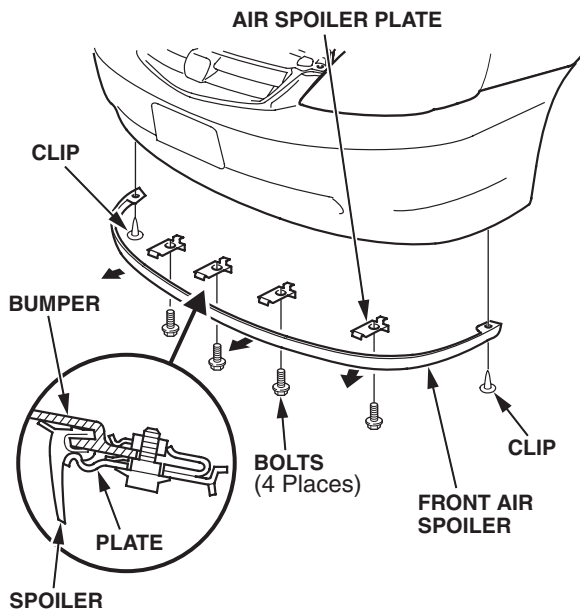
4. Install the front bumper air spoiler to the bumper.
5. Install the four spoiler plates and the two push clips.

6. Install the four bolts, and torque them to 9.8 N.m (7.2 lb-ft).
7. Clean any excessive adhesive from the front bumper air spoiler.
8. Tell the customer not to disturb the front bumper air spoiler for 24 hours to allow the adhesive to cure completely.
