## Excessive Engine Vibration or Noise

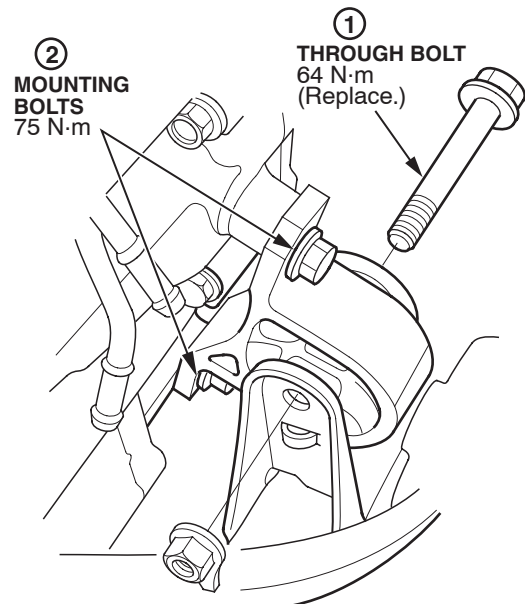
1. Remove and discard the front engine mount and the through bolt.

2. Install the new front engine mount. Torque the through bolt and the mounting bolts in the order shown.

**NOTE:** Make sure you torque the bolts in the proper order with the vehicle sitting on the ground. If not, the noise and vibration may return.
