Model	Applicable To	File Under	Bulletin No.
1996 – 98 CIVIC	ALL MODELS (Except VTEC)	ENGINE	98-014
			Issue Date MARCH 1998

Rattle From Exhaust Pipe A

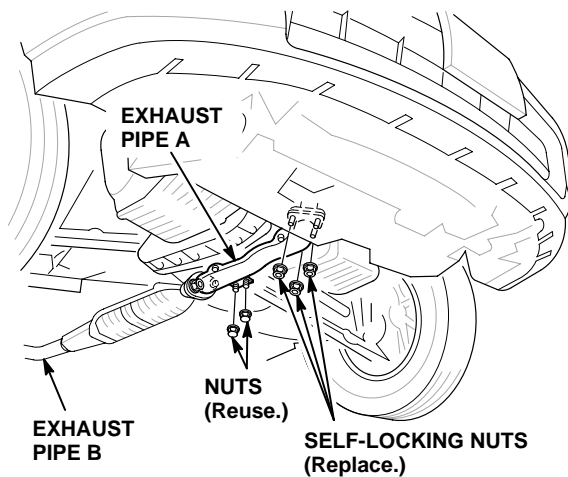
1. Raise the vehicle, and allow the exhaust system to cool.
2. Remove and discard the three self-locking nuts securing exhaust pipe A to the exhaust manifold.

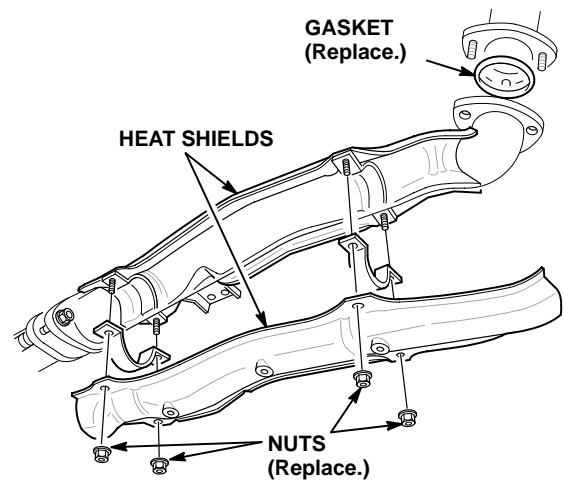
3. Remove and retain the two nuts securing exhaust pipe A to the mounting bracket, then lower the pipe from the exhaust manifold.
4. Remove the heat shields from exhaust pipe A.

5. Install the new heat shields using the four nuts from the kit, and torque the nuts to 9.8 N-m (7.2 lb-ft).
6. Reinstall exhaust pipe A to the exhaust manifold using three new self-locking nuts and a new gasket. Torque the nuts to 33 N-m (25 lb-ft).
7. Reinstall the two nuts onto the mounting bracket.
