Product Update: CR-V Throttle Cable

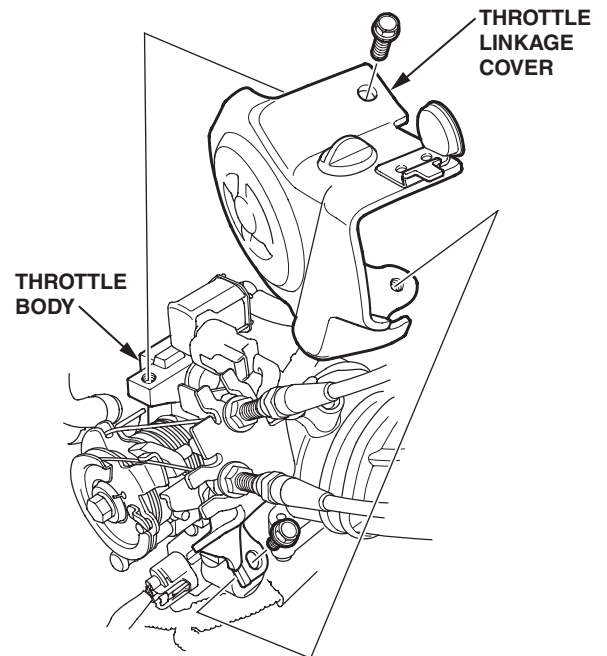
1. Remove the throttle linkage cover from the throttle body.

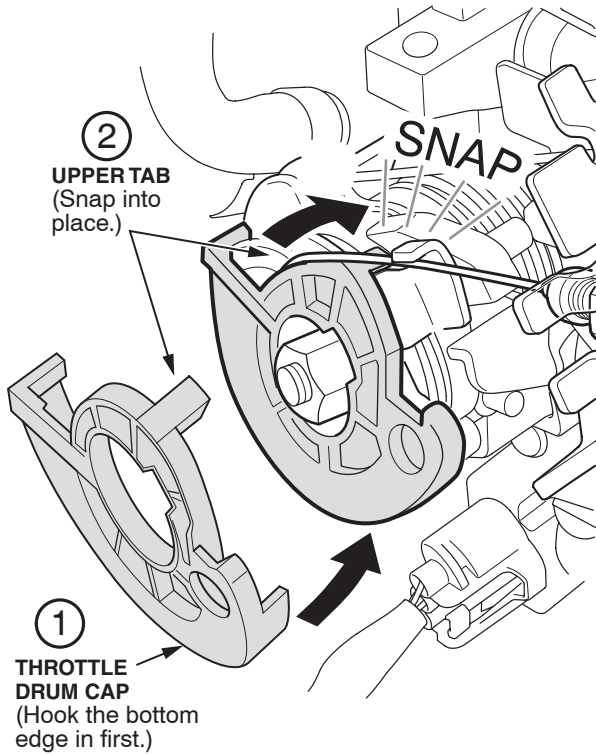
Contamination on the throttle drum can cause the throttle cable to move with the cruise control cable. If this happens when you cancel the cruise control function, the throttle cable can jump its track on the throttle drum, resulting in no throttle response.

2. Install the throttle drum cap on the throttle drum by pressing its lower half onto the drum and then snapping its upper tab into place.

3. Rotate the throttle drum, and make sure the cap is completely seated.
4. If there is a gap between the cap and the throttle drum, remove and discard the cap, then repeat steps 2 and 3 with a new cap.
5. Install the throttle linkage cover, and torque the bolts to 12 N·m (8.7 lb-ft).
6. Center-punch a completion mark above the fifth character of the engine compartment VIN.
