1999 Legend PDI Information

Most of the features, equipment, and delivery preparation procedures for the 1999 Legend are the same as for previous models. This service bulletin describes those things that are unique to the 1999 model.

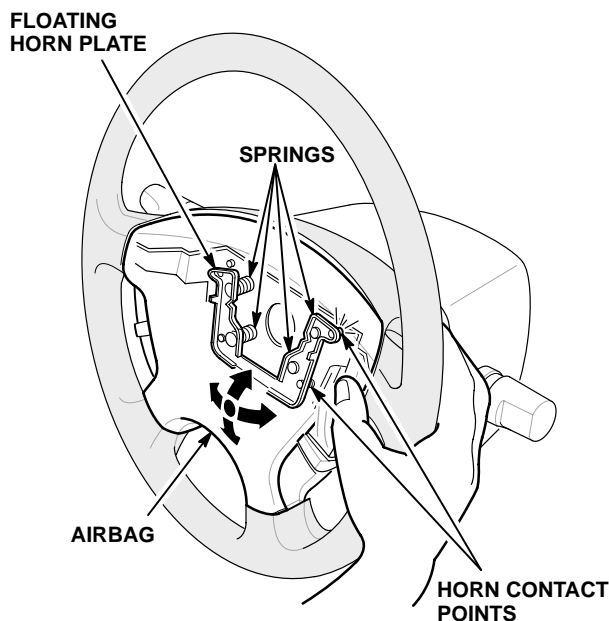
FLOATING CENTER PAD HORN SWITCH

In place of the horn buttons used on the previous Legend steering wheels; the '99 model uses the entire center of the steering wheel as the horn switch. This change is done by floating the airbag in the steering wheel.

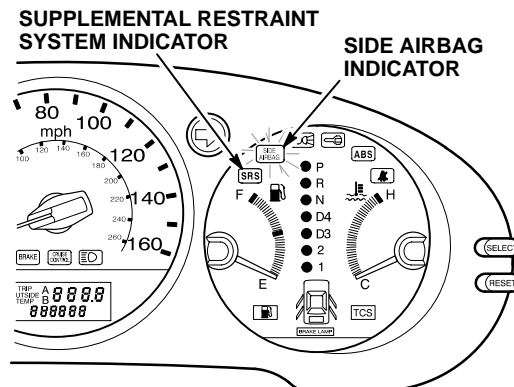
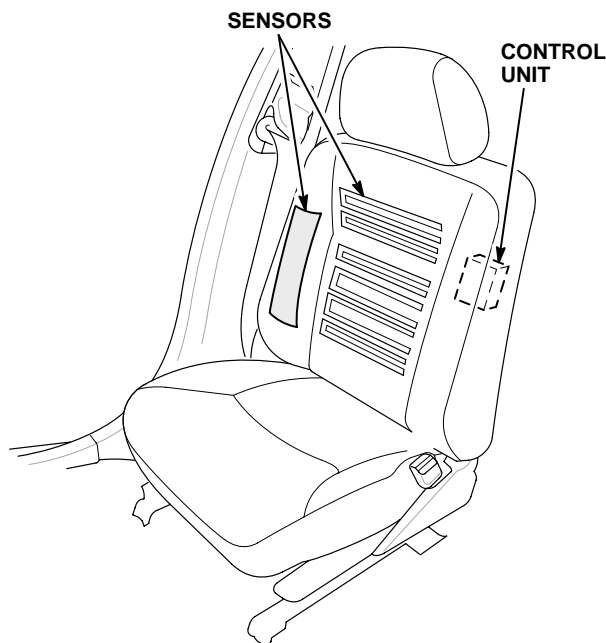
SIDE AIRBAGS

If the SRS unit determines that the front passenger's head is in the deployment path of the side airbag, it automatically disables the airbag. When the side airbag is disabled, the Side Airbag indicator light in the gauge assembly comes on to alert the driver that the passenger's side airbag will not deploy in a side impact.

When the OPDS detects that the passenger's head is in the path of deployment for more than three seconds, the side airbag light comes on. The light stays on for three seconds longer than the sensor detects the blocked path.

The side airbags in both seats deploy through the bolster seam. The cover is sewn with a special stitching method that allows reliable deployment. You must replace the seat covers with the correct part. Do not make repairs to the seat cover; instead, replace the seat cover as a unit.

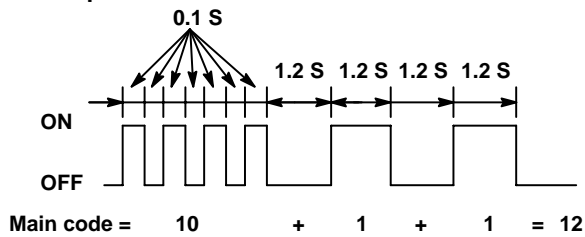
Example:

Additional SRS codes have been added for the side airbag system, and the SRS light indicates these codes differently. For example, the "10" in codes 11 through 14 is indicated by four short blinks. Refer to the 1999 Legend Shop Manual Supplement for more information.

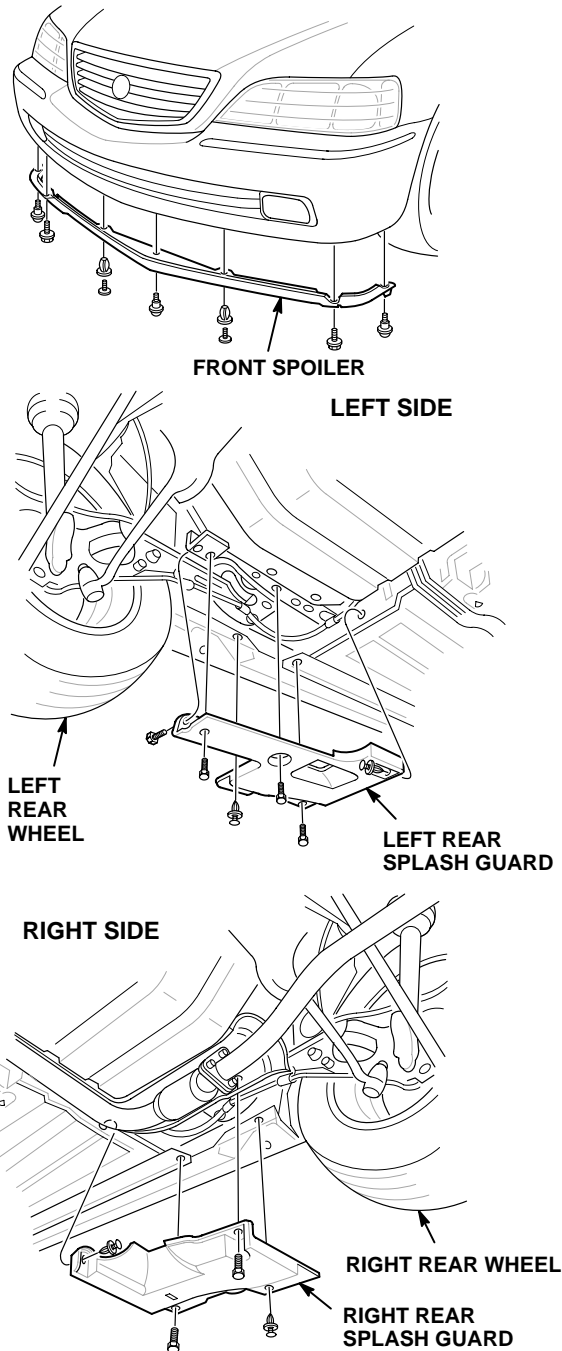
FRONT SPOILER AND REAR SPLASH GUARDS

The front spoiler and rear splash guards are not installed at the factory. They must be installed during PDI.
