1997-99  
CR-V

98-050

## Clunking Noise From the Front Suspension

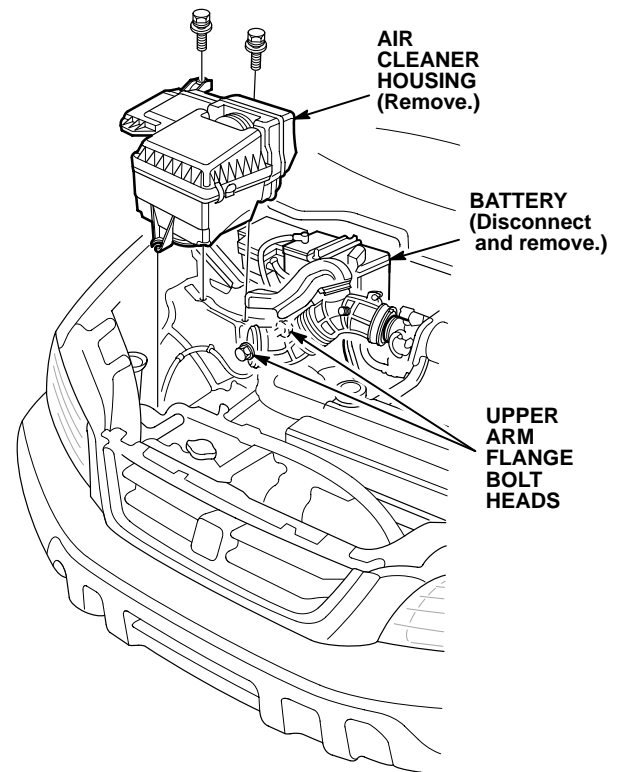
3. Raise the vehicle on a lift, just enough to lift the wheels off the ground.
4. Remove the air cleaner housing.

- Loosen the two flange bolts from the right upper arm. Repeat this step on the left side.
