Applies To: **1999 Accord** – ALL  
**2000 Accord** – See VEHICLES AFFECTED

April 2000

## Driver's Door Mirror Vibrates

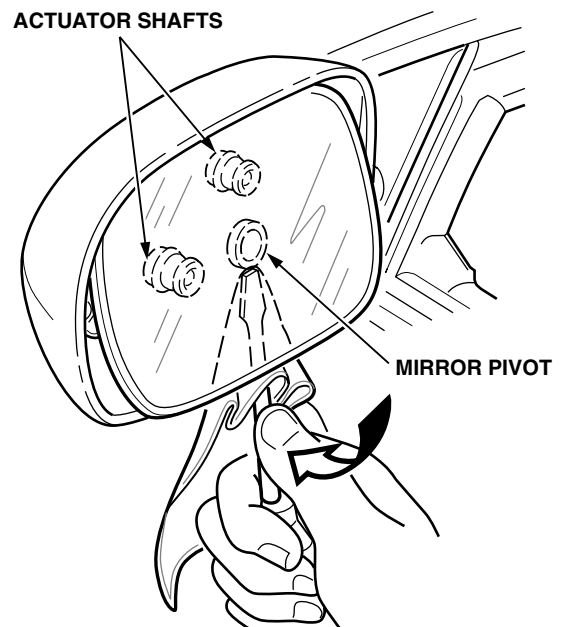
1. Pry out the bottom of the mirror with a screwdriver wrapped in a shop towel. Continue to pry until the actuator shafts come out of the actuator or the mirror.

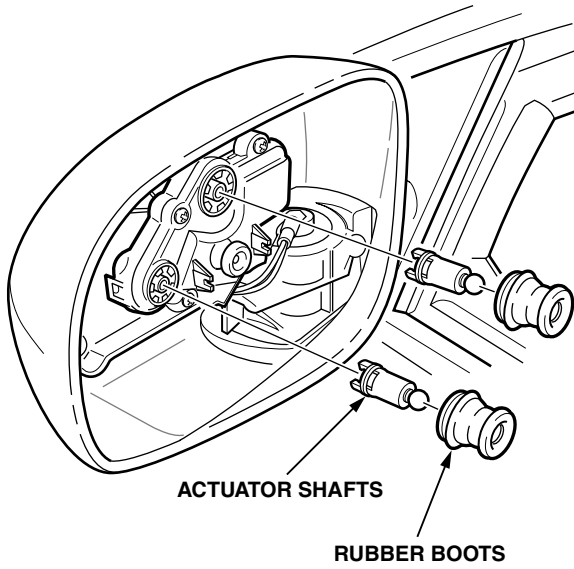
2. If the actuator shafts are still attached to the mirror, remove them and reinstall them on the actuator. Make sure the rubber boots are properly seated in the actuator.

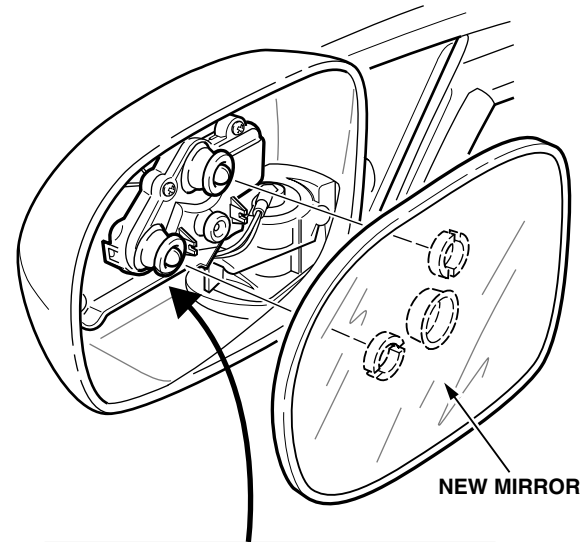
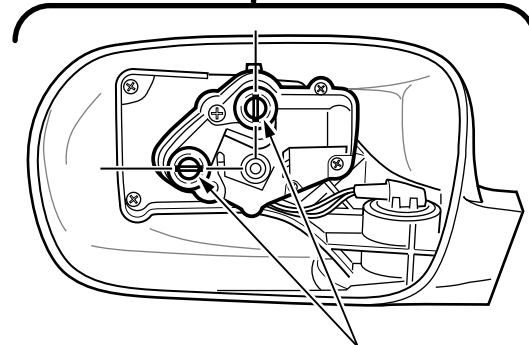
3. Before installing the new mirror, do this:

- Make sure the tabs on the actuator shafts are lined up with the slots on the back of the mirror.
- Apply grease to the mirror pivot and the actuator shafts.

4. Align the pivot and the actuator shafts with the mirror, then carefully push on the mirror until the pivot and actuator shafts are properly seated. If the pivot and the actuator shafts will not engage, warm the shafts and the pivot with a heat gun.
5. Clean the mirror with glass cleaner.
6. Check the operation of the power mirror actuator in all four directions.
7. Test-drive the vehicle to verify that the mirror does not vibrate.

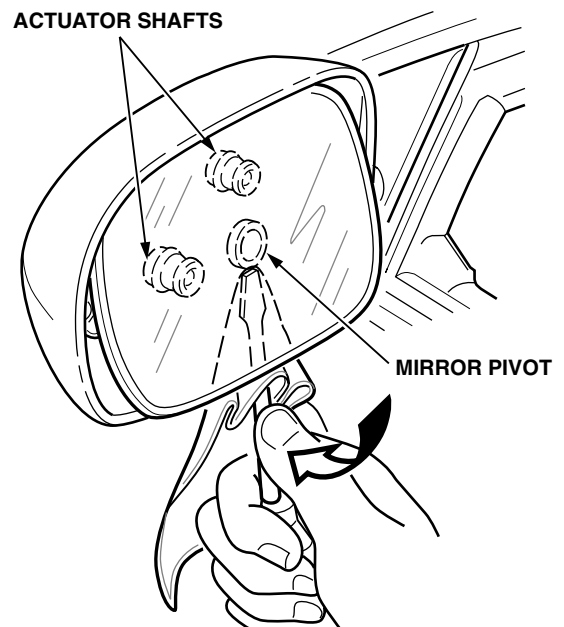
1. Pry out the bottom of the mirror with a screwdriver wrapped in a shop towel. Continue to pry until the actuator shafts come out of the actuator or the mirror.

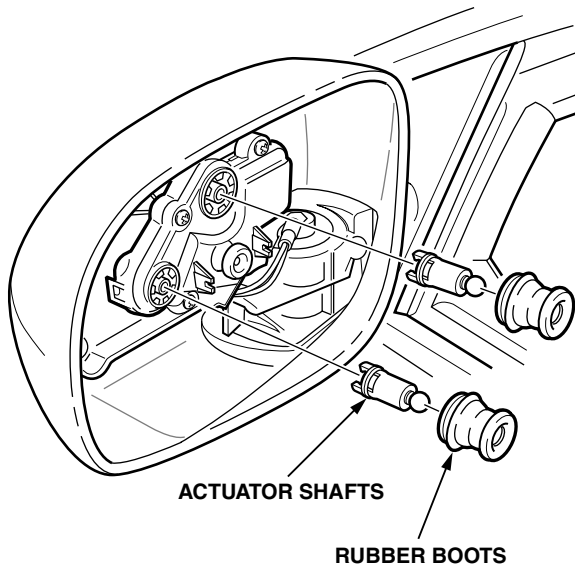
2. If the actuator shafts are still attached to the mirror, remove them and reinstall them on the actuator. Make sure the rubber boots are properly seated in the actuator.

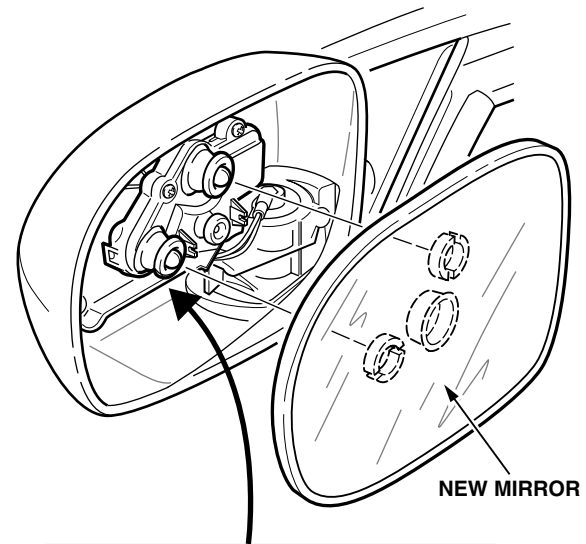
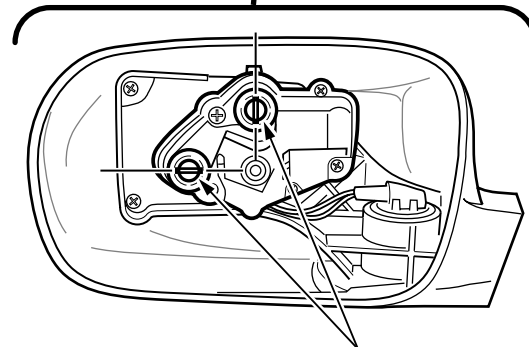
3. Before installing the new mirror, do this:

- Make sure the tabs on the actuator shafts are lined up with the slots on the back of the mirror.
- Apply grease to the mirror pivot and the actuator shafts.

Tabs on the actuator shaft balls should be horizontal and vertical as shown.

4. Align the pivot and the actuator shafts with the mirror, then carefully push on the mirror until the pivot and actuator shafts are properly seated. If the pivot and the actuator shafts will not engage, warm the shafts and the pivot with a heat gun.
5. Clean the mirror with glass cleaner.
6. Check the operation of the power mirror actuator in all four directions.
7. Test-drive the vehicle to verify that the mirror does not vibrate.
