Applies To: **2003 Accord KX 2-Door** –
From VIN 1HGCM8...3A900001 thru 1HGCM8...3A900836

Door Window Molding Is Wrinkled

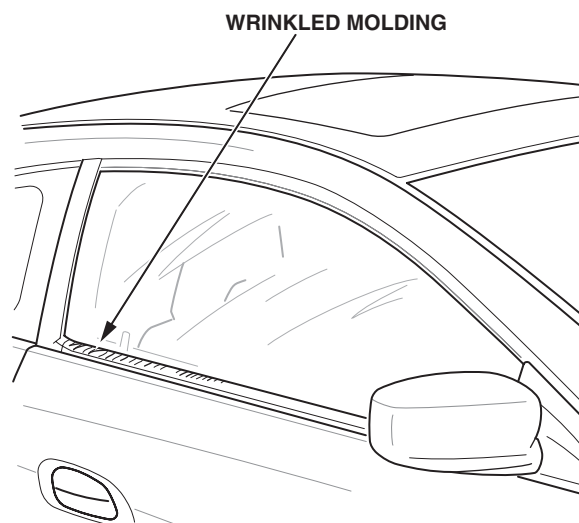
The door window molding is wrinkled on one or both sides.

1. Inspect both door window moldings for wrinkles.

Replace the affected door window molding(s).

2. Replace the door window molding(s) as needed; refer to the 2003 Accord Shop Manual.
