Applies To: **1996-99 Civic – ALL****February 2000****2000 Civic – KE 2-door from VIN 1HGEM11..YL600001 thru 1HGEM11..YL600391**

Rattle From the Hood

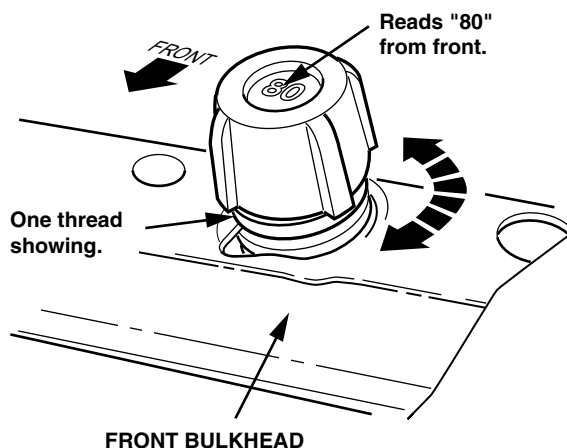
1. Adjust each hood edge cushion so only one thread is showing and the "80" on the top is in the position shown.

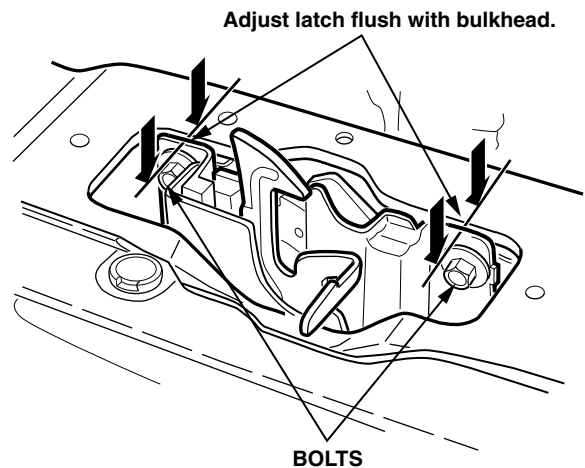
2. Loosen the hood latch mounting bolts, and adjust the latch so it is flush with the top of the bulkhead.
