Applies To: **2001 Civic 2-Door – ALL**
2002 Civic 2-Door – See VEHICLES AFFECTED

July 2002

Rattle From the High Mount Brake Light

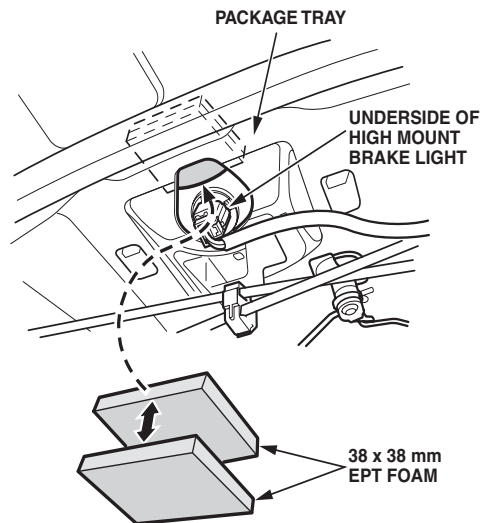
The felt that is attached to the mounting hook on the package tray has been pushed out of position.

1. Cut two 38 x 38 mm pieces of 10T EPT foam.
2. Remove the backing and attach the two pieces of foam together, adhesive side to adhesive side.
3. Open the trunk.
4. Insert the foam between the package tray and the parcel shelf at the opening for the high mount brake light. Install the foam at the rear of the opening for the high mount brake light wiring. Push the foam into the rear of the opening toward the rear window.
