Clicking From the Rear Brakes

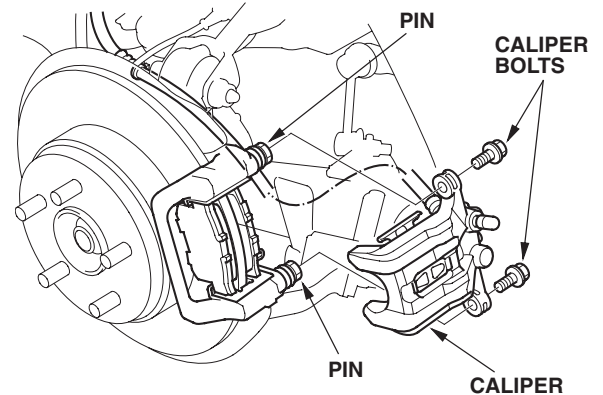
1. Remove the rear wheels.
2. Hold the pins with a wrench; be careful not to damage the pin boots. Remove the caliper bolts, and remove the caliper from the caliper bracket.

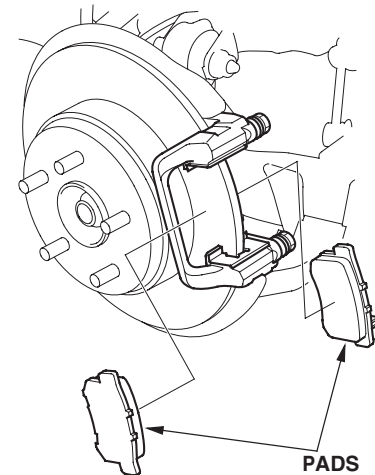
3. Remove the pads.

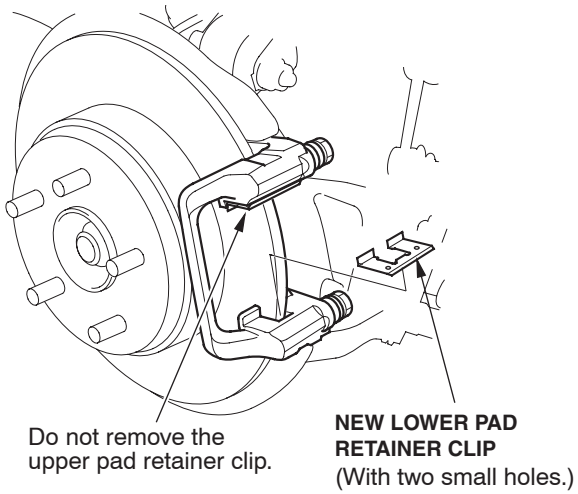
4. Remove and discard the lower pad retainer clip, then install the new clip.

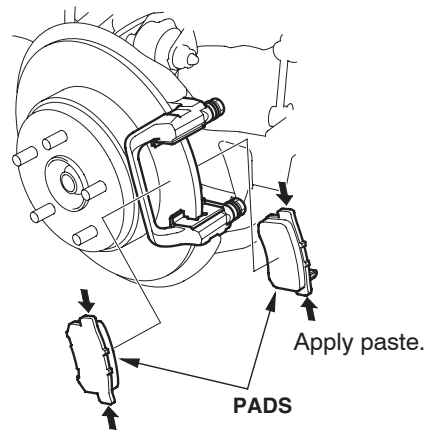
5. Apply Dow Corning Molykote M77 assembly paste to the areas indicated by the arrows. Wipe off any excess paste. Do not get any paste on the disc or pad surfaces.
