Model
1996-99
3.5 Legend
1996-98
3.2TL

Bulletin No.
99-538
Issue Date
AUGUST 1999

Safety Recall: Extension Shaft Sealing Bolt

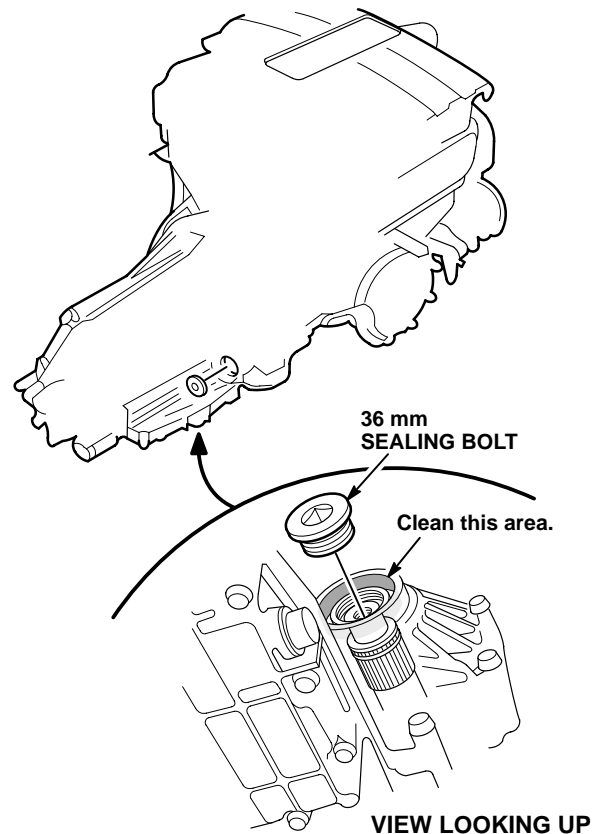
1. Make sure the vehicle is in Park, then raise the vehicle on a hoist.
2. Use brake cleaner and compressed air to clean the area around the 36 mm sealing bolt. Wear eye protection.

3. Remove the 36 mm sealing bolt.
4. Use brake cleaner and compressed air to clean the threads in the transmission housing. Wear eye protection.
5. Install the O-ring on the new sealing bolt.
6. Install the new 36 mm sealing bolt. Do not use any thread lock or thread sealer. Torque the bolt to 78 N-m.
7. Lower the vehicle.

Replace and properly torque the 36 mm sealing bolt.

36 mm Sealing Bolt Set: P/N 90082-PY5-305
(The set includes a new sealing bolt and O-ring.)
